Errata

J721S2, TDA4VE, TDA4AL, TDA4VL, AM68A Processor Silicon Revision 1.0

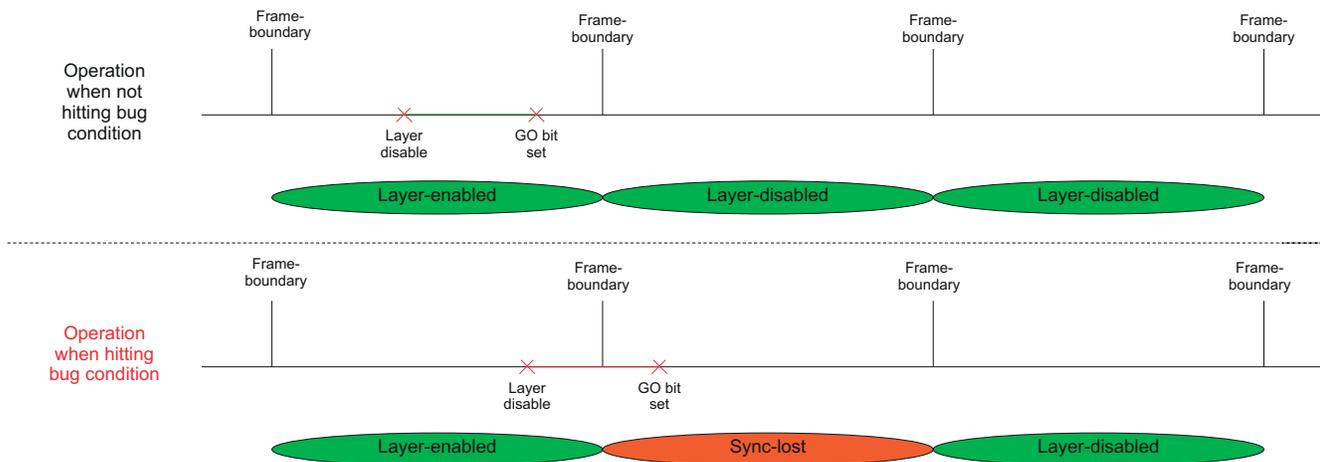
Figure 3-1. Bug Condition

i2097 DSS: Disabling a Layer Connected to Overlay May Result in Synclost During the Next Frame

Details: Disabling a layer (for example VID1) connected to an OVR (that is toggling DSS_VID_ATTRIBUTESx[0] ENABLE from 1 to 0) may result in synclost during the next frame. The synclost may result in a corrupted or blank frame (all pixel data sent out of DSS during the frame is 0x0). The occurrence of synclost is dependent on the timing of setting the GO bit (that is DSS_VP_CONTROL[5] GOBIT to 1) vis-à-vis the disabling of the layer. If the “disable layer” MMR write operation and “set GO bit” MMR write operation happens within the same frame boundary, no synclost occurs. If the operations happen across the frame boundary, then synclost occurs (for one frame). The design automatically recovers and returns to normal operation from the next frame after GO bit is set, see [Figure 3-1](#).

Workaround(s): A simple software workaround exists. In the workaround, prior to disabling a layer on the OVR, it is moved to the “non-visible” area of the OVR (for example: `DSS_OVR_ATTRIBUTES_x[17-6] POSX = max_value_of_posx` or `DSS_OVR_ATTRIBUTES_x[30-19] POSY = max_value_of_posy`). This avoids the synclost when the layer is disabled.

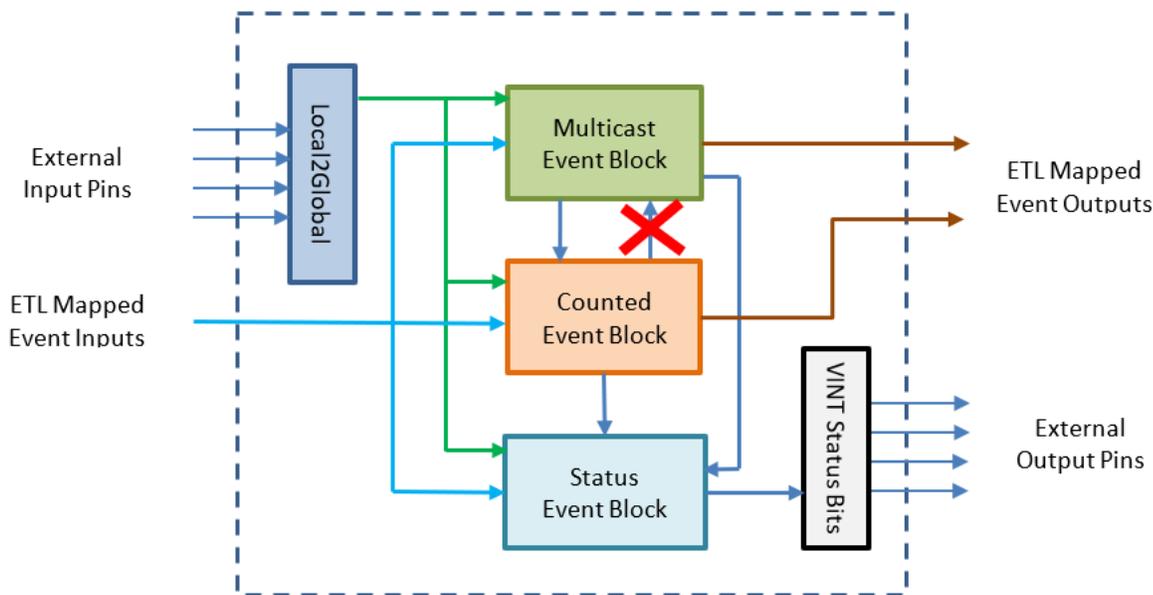
Figure 3-3. Interrupt Aggregator Version 1.0

An issue was found after design that could cause the IA to deadlock. The issue occurs when event “loops” occur between these three processing blocks. It is possible to create a situation where a processing block can not output an event because the path is blocked, and since it can not output an event, it can not take any new input events. This inability to take input events prevents the output path from being able to unwind, and thus both paths remain blocked.

Figure 3-3 shows the conceptual block diagram of IA 1.0. Potential loops are avoided by adopting the policy of not allowing the counted event block to send events to the multicast block. This method was chosen because it is more common to split an event first, and then count one while sending the other elsewhere. With this path blocked by convention, it is not possible for a single event to visit any block more than once and thus not possible for paths to become blocked so long as the outputs remain unblocked.

By following the conventions outlined here, the system is safe from looping hazards that can create a deadlock scenario.

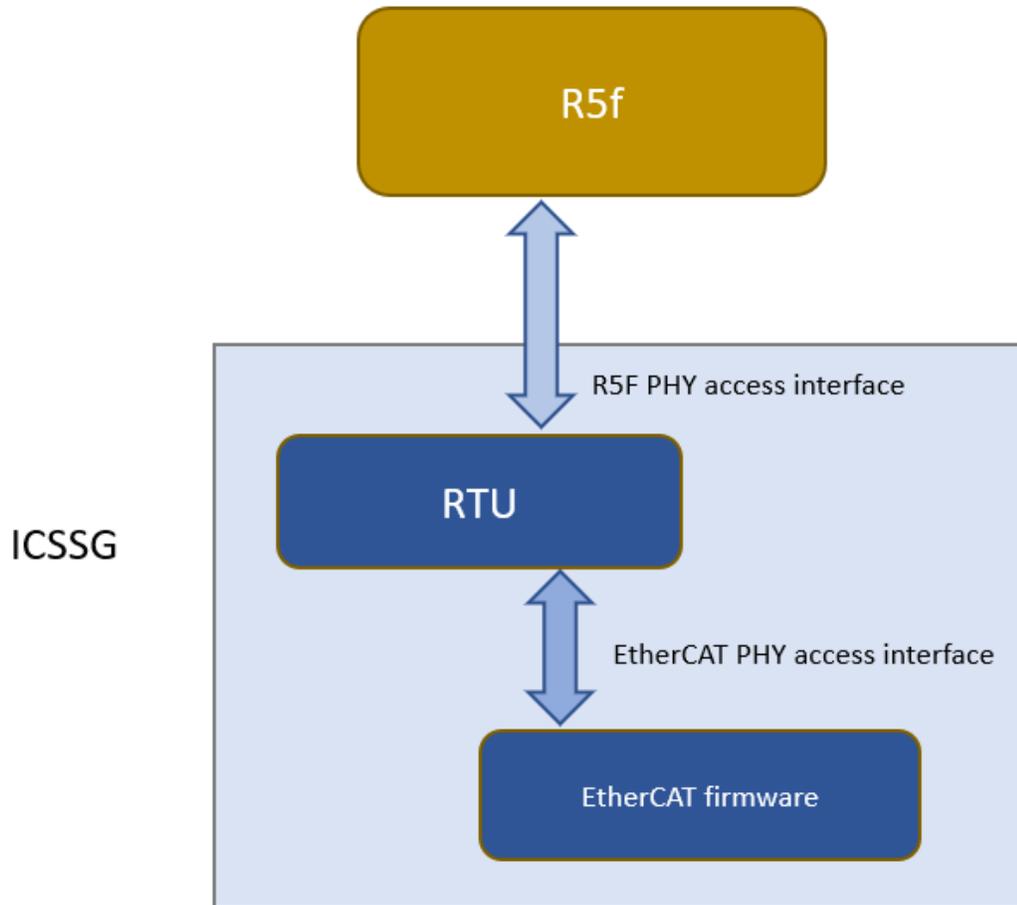
Figure 3-4. MDIO Emulation via Manual Mode using PRU Core

i2329 (continued) MDIO: MDIO interface corruption (CPSW and PRU-ICSS)

EtherCAT will continue to use PHY fast link detection via MDIO MLINK bypassing state m/c for link status (as this path is not affected by errata). This makes sure that cable redundancy related latency requirements are still met.
